Intel® Virtual RAID on CPU (Intel® VROC)

7.6 PV Windows Customer Release Notes

April 2021

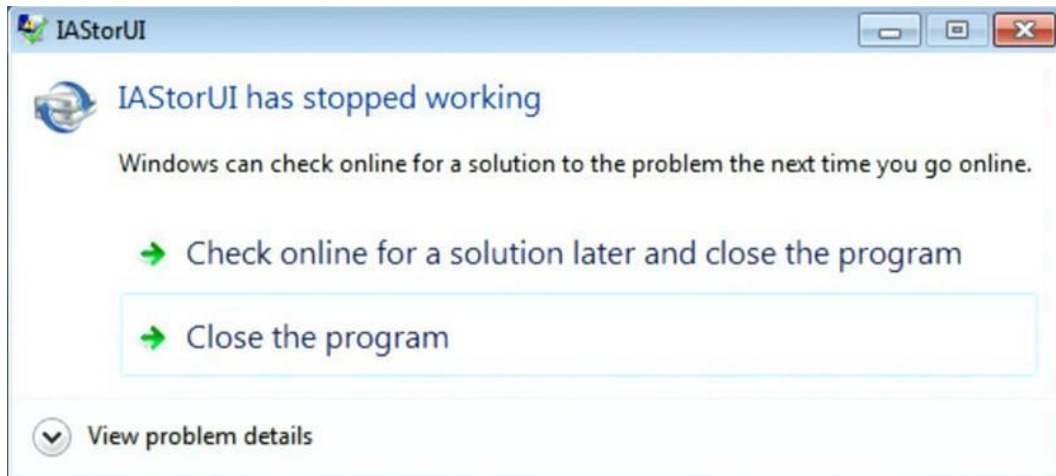
When installing Intel VROC 6.1 onto a platform with Win7 the following message may be displayed after the package installation reboot:

To resolve this issue, the Microsoft .NET Framework needs to be updated to version 4.5.1. The following link can be used to download:
